Translation of Corrosion test report from FORCE 2005

Corrosion test of grease for StAl conductors

FORCE Technology has made a salt fog test of steel plates applied 5 different greases, used for overhead conductors.

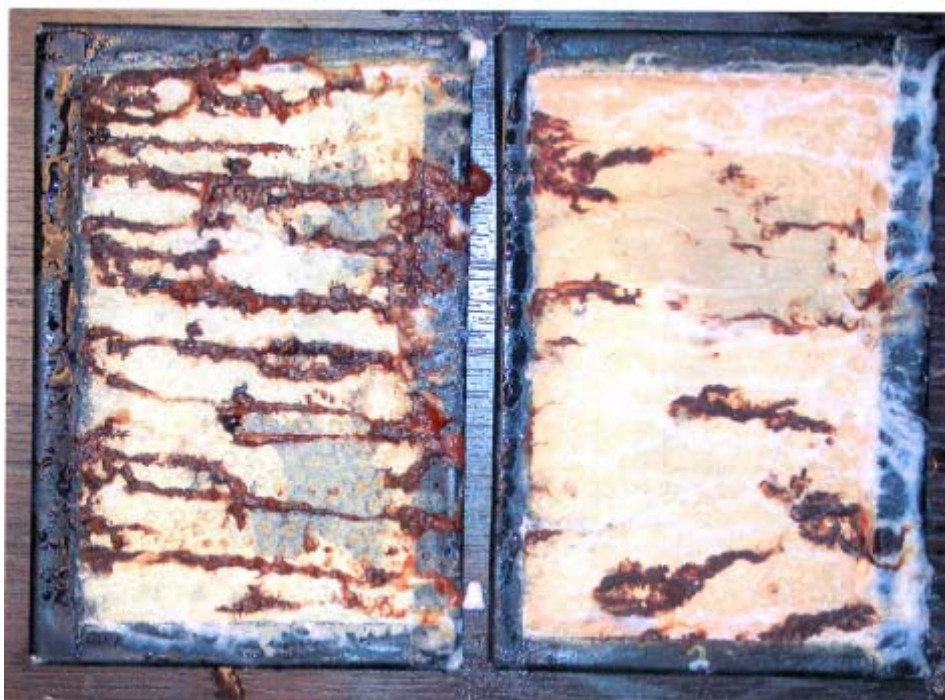
Picture 14. Plate 1, 2 after 2212 hours exposure

| Plade nr. | Fedt-Fab. | 1. inspektion, 216 t | | 2. inspektion, 511 t | | 3. inspektion, 1039 t | | 4. inspektion, 1467 t | | 5. inspektion, 2212 t |
|---|---|---|---|---|---|---|---|---|---|---|
| 1 | Ceritol SV 2KF | 2 % HR | 0 | 2 ¹⁾ | 0 | 30 | 2-40 | 5 %RR+95 %HR | - | 20%RR+80%HR |
| 2 | Castrol Rustilo 450 | 60 % HR | 7-24 | 95 % HR | 30-40 | 100 %HR | 0-40 | 100 %HR | - | 10%RR+80%HR |

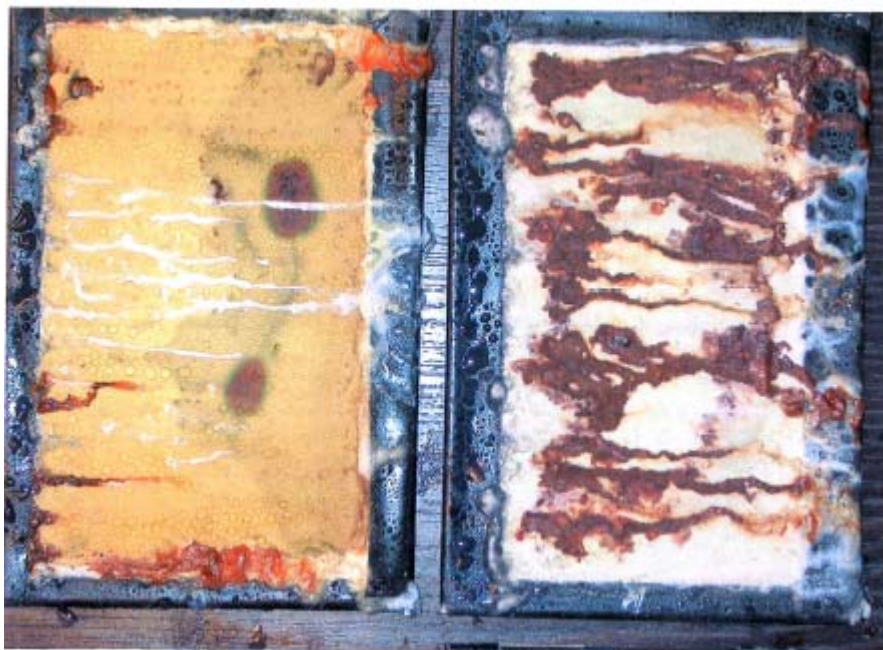
Picture 15. Plates 3,4 after 2212 hours exposure

At plates 3 and 8 with Castrol Rustilo 431 the zinc covering is mostly wasted away at the whole surface at both plates, and the protection is therefore considered to be less than with Castrol Rustilo 450. The final judgment of the 5 greases protection ability judged from salt fog test is therefore:

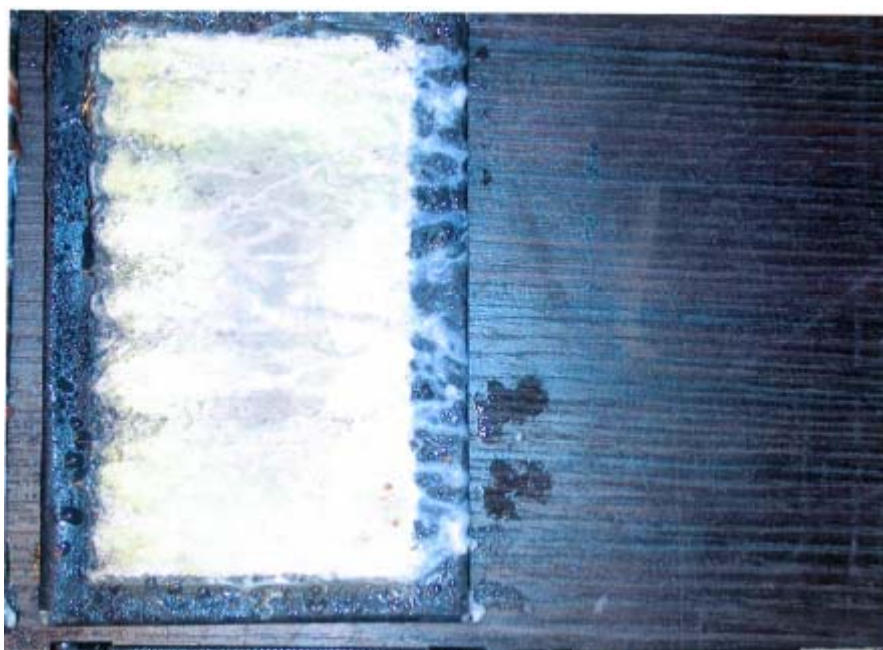
Picture 16. Plate 5 after 2212 hours exposure

The examination confirm, that OCG 5000 (plate 5 and 10) has made the best protection, as there are only minor extends of rust starting along the tape edges. At plate 10 the zinc covering at major parts of the plate is without considerable corrosion). The thicker grease film at plate 10 at 0.45 mm is thus having a positive effect at the protection compared to the plate 5, where the thickness of the grease film is 0.40 mm

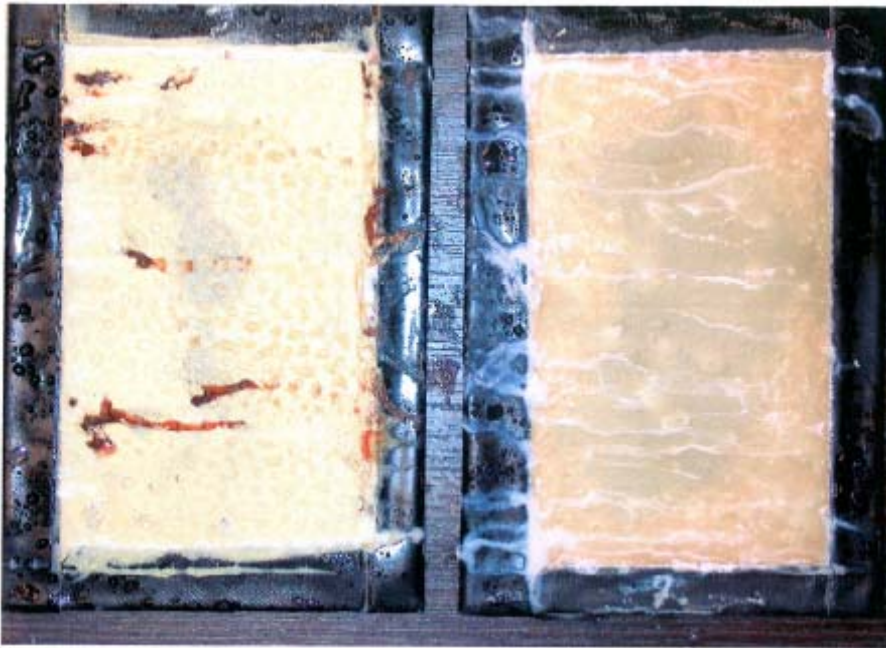
Picture 17. Plates 6, 7 after 2212 hours exposure

The better protection from a thicker grease film is also shown by comparing plates 2 and 7 (Castrol Rustilo 450) as the zinc covering at the last mentioned is intact and without considerable corrosion at 50% of the plate surface. Contrary to this the zinc covering at plate 2 is mostly wasted away at the whole surface.

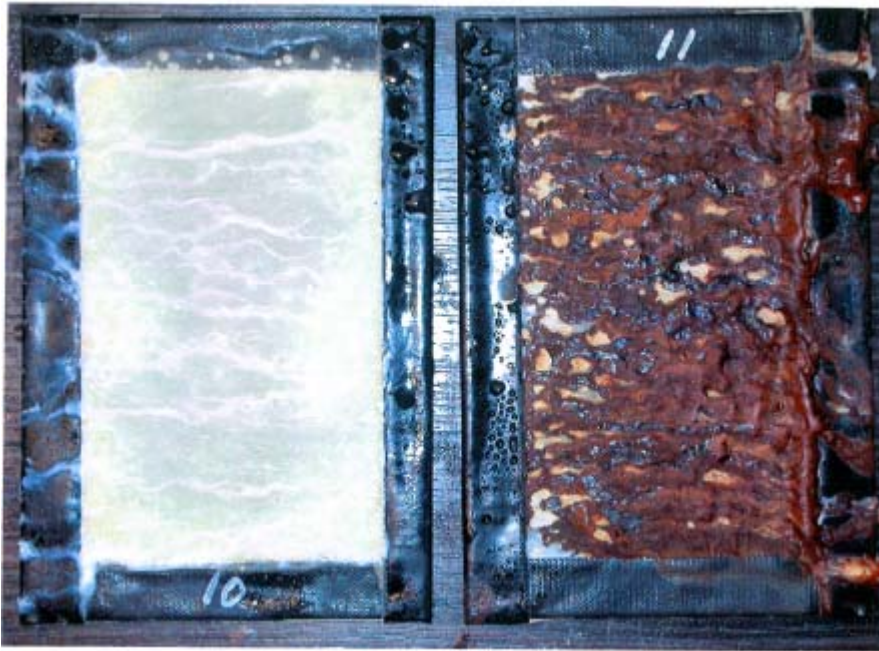
Picture 19. Plates 10, 11 after 2212 hours exposure

In table 3 it shows, that after 1039 hours salt fog exposure there are yet only white rust (white rust = corrosion products from zinc) at the greased zinc coated steel plates. At the reference plate without grease (no. 11), there is red rust at 5 % of the surface already at 1. inspection after 216 hours exposure. At the greased plates the first red rust appear after 1467 hours of exposure at plate 1 (Ceritol SV 2KF) and plate 4 (OCG 1000). After finished exposure only plate 7 (Castrol Rustilo 450) and plate 10 (OCG 5000) are totally without red rust.

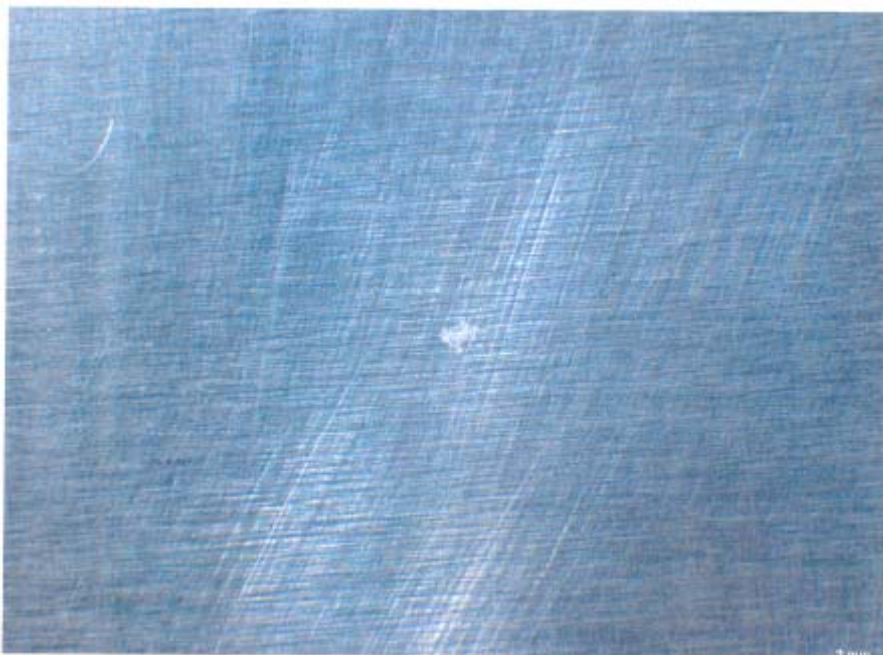
| Testplade | Fedtfabrikat | % af overflade med korrosion |
|---|---|--|
| 1A | Ceritol SV 2KF | under 1 %, overfladisk korrosion |

Picture 20. Stereo microscope. Plate A1 after 2212 hours exposure
In the middle of the picture, a small superficial corrosion attack is visible after removing the grease film. Note that the magnification is specified in right bottom corner

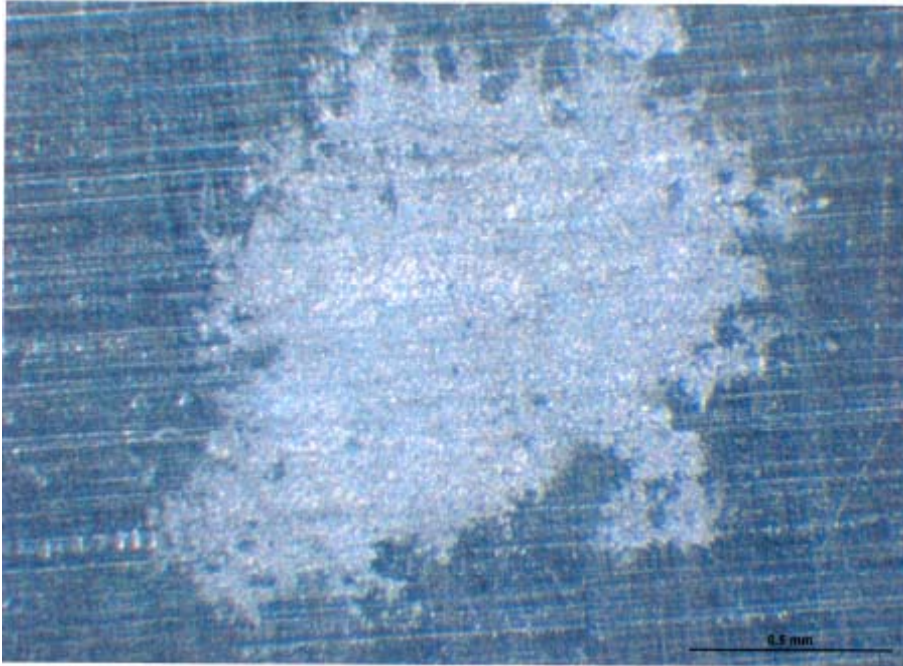
| Testplade | Fedtfabrikat | % af overflade med korrosion |
|---|---|--|
| 3A | Castrol Rustilo 431 | ~ 2 %, overfladisk korrosion |

Picture 21. Stereo microscope. Plate A3 after 2212 hours exposure
Photo from stereo microscope showing superficial corrosion attack at aluminum surface

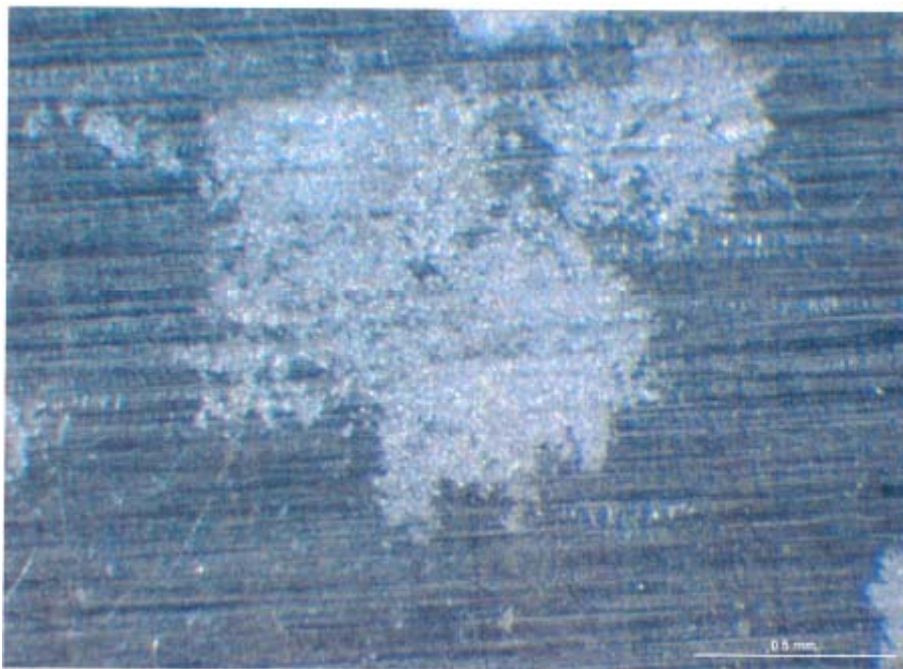
| Testplade | Fedtfabrikat | % af overflade med korrosion |
|---|---|--|
| 8A | Castrol Rustilo 431 | ~ 2 %, overfladisk korrosion |

Picture 22. Stereo microscope. Plate A8 after 2212 hours exposure
Photo from stereo microscope showing superficial corrosion attack at aluminum surface

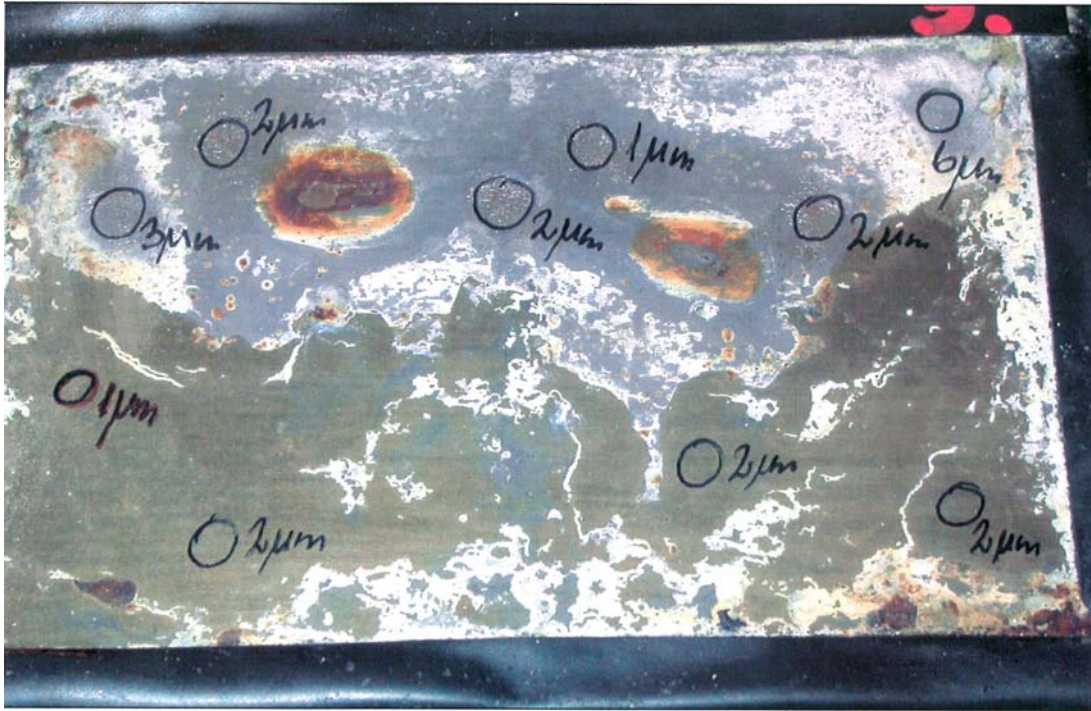
Plate 3 – 2212 hours

The zinc covering is mostly wasted away at the whole plate surface except upper right corner, where a remaining zinc layer at 6 µm is measured.

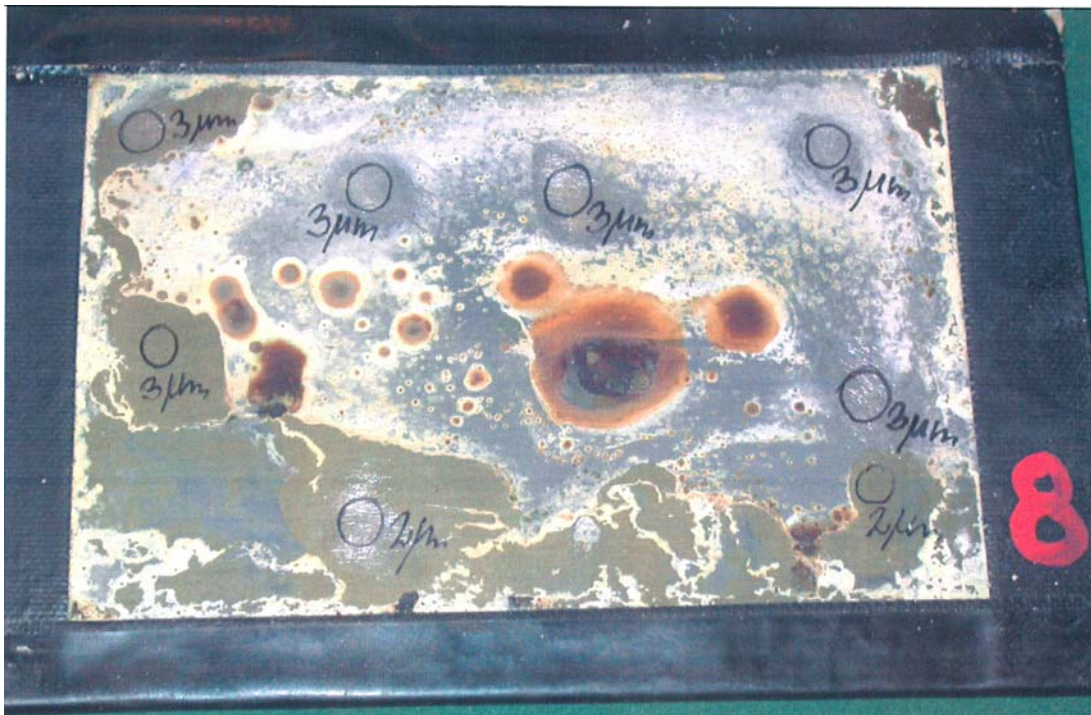
Plate 8 – 2212 hours

The zinc covering is mostly wasted away at the whole plate surface, as the remaining zinc layer is negligible.

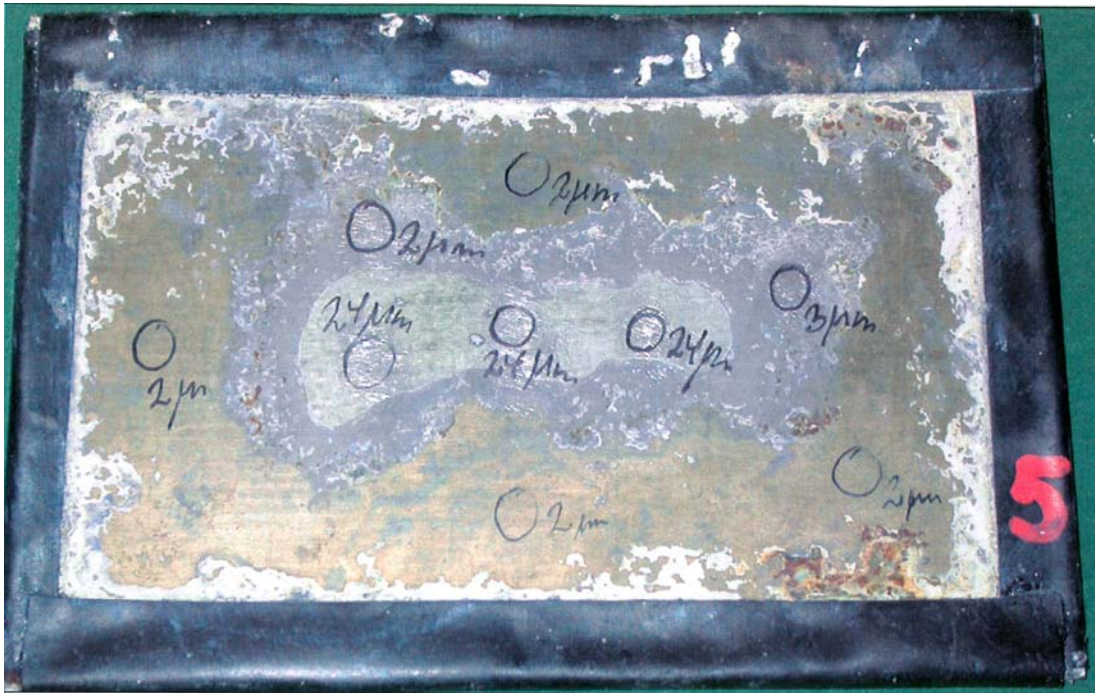
Plate 5 – 2212 hours

The zinc covering is mostly wasted away at most of the plate surface along the tape edges. At the middle of the plate, in an area of app. 20 % of the surface, a zinc layer at 24 μm , corresponding to the layer before exposure, is measured. The grease has thus given a firm protection in this area.

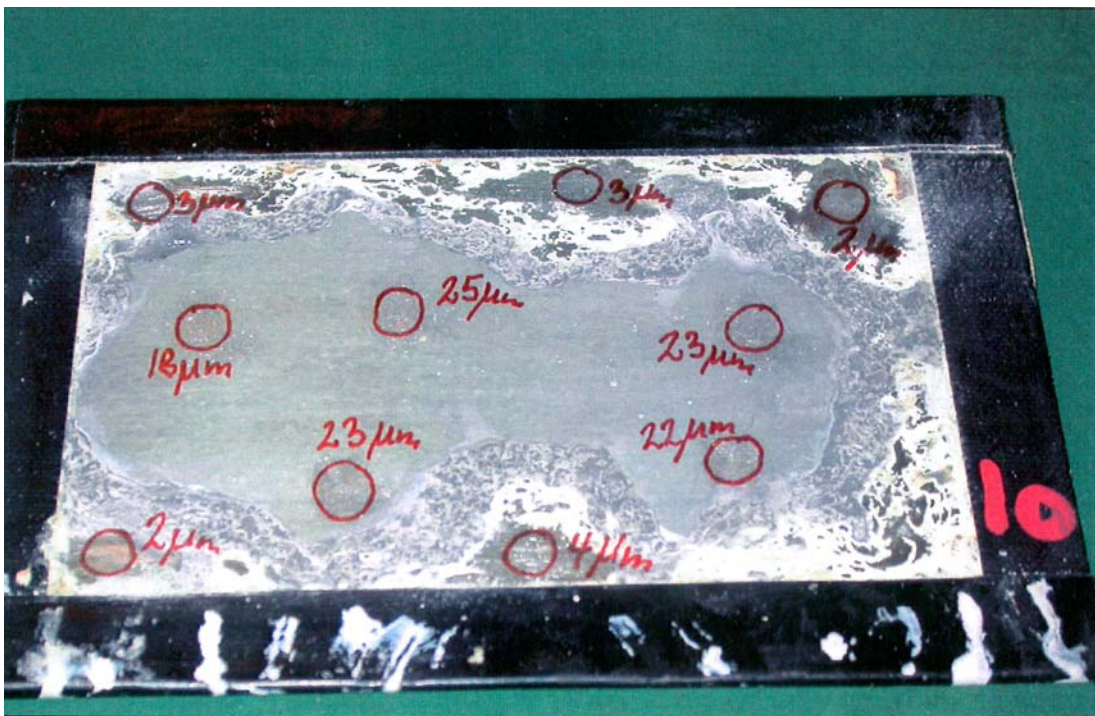
Plate 10 – 2212 hours

The zinc covering is shown to be mostly wasted away along the tape edges, where 2-4 μm remaining zinc layer is measured. The zinc covering is mostly intact at the rest of the plate surface (app. 60 % of the surface), where zinc layer thicknesses corresponding to the original is measured.
