Thermal Aging of Conventional Conductor Systems

**Task: Comparison between ACSR and TACSR
Penguin Conductor**

Do Nascimento, C.A.M. and UEDA, S. - Brazil

Stockholm, May 2010.

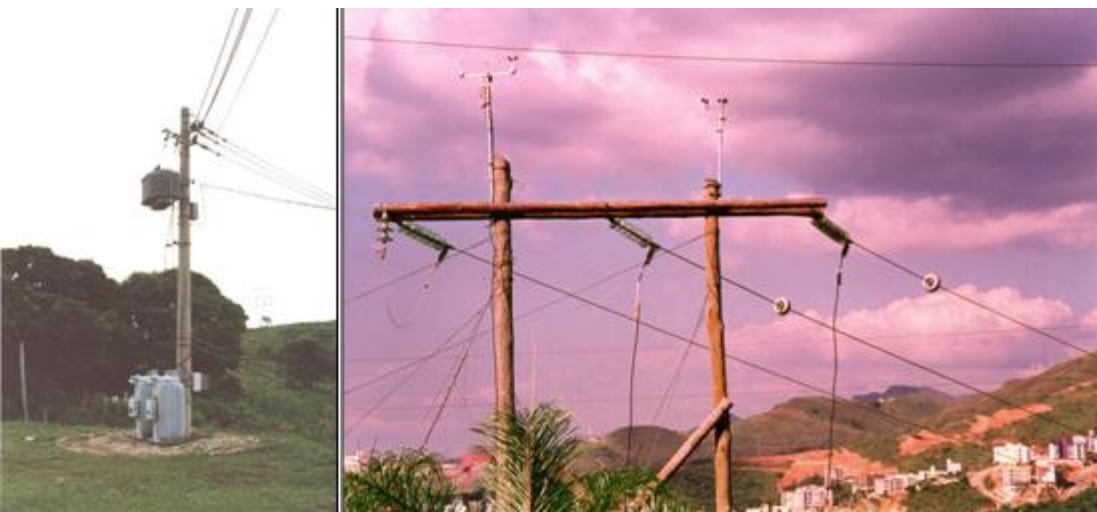
Figure 2 – Power Transformer System (300 kVA), two Reguladores de Tensão, Power Donut Sensor of Monitoring Temperature System and Weather Station in Experimental Line

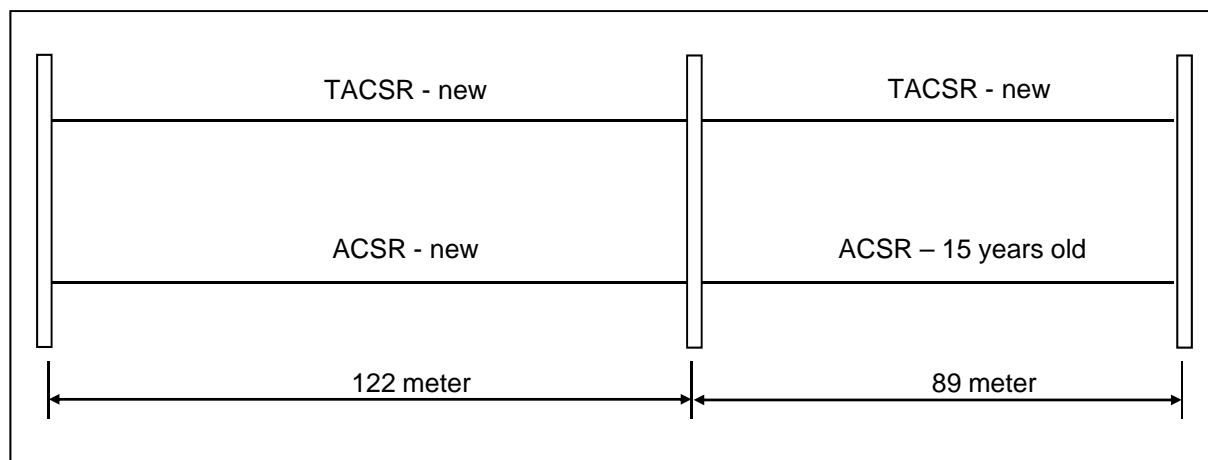
Figure 1 - Configuration of ACSR and TACSR Conductors in the Exerimental Line.

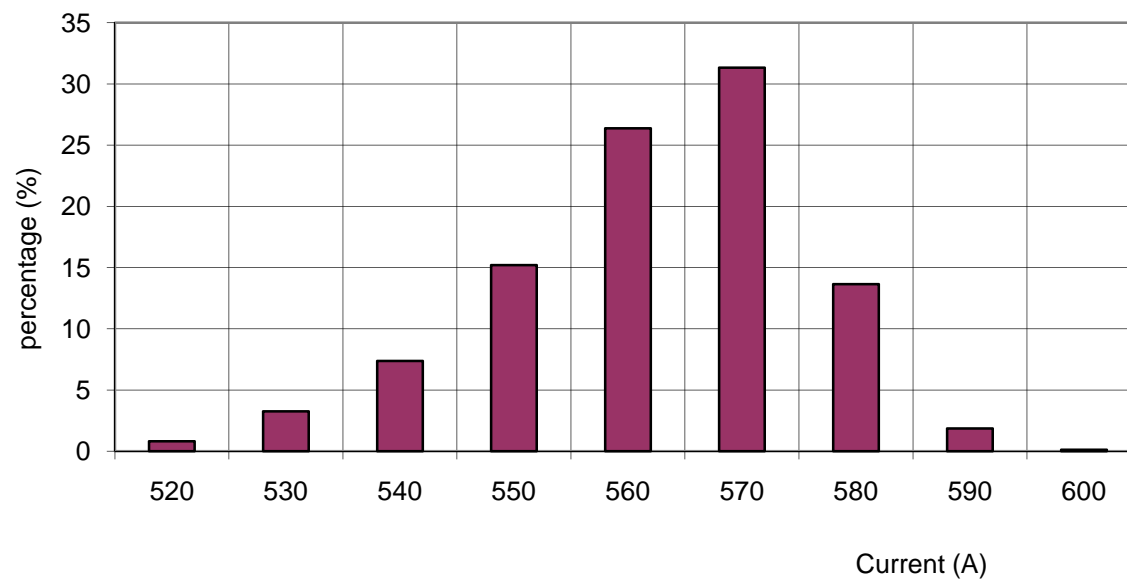
Figure 4 - Hourly average of current in the Experimental Line.

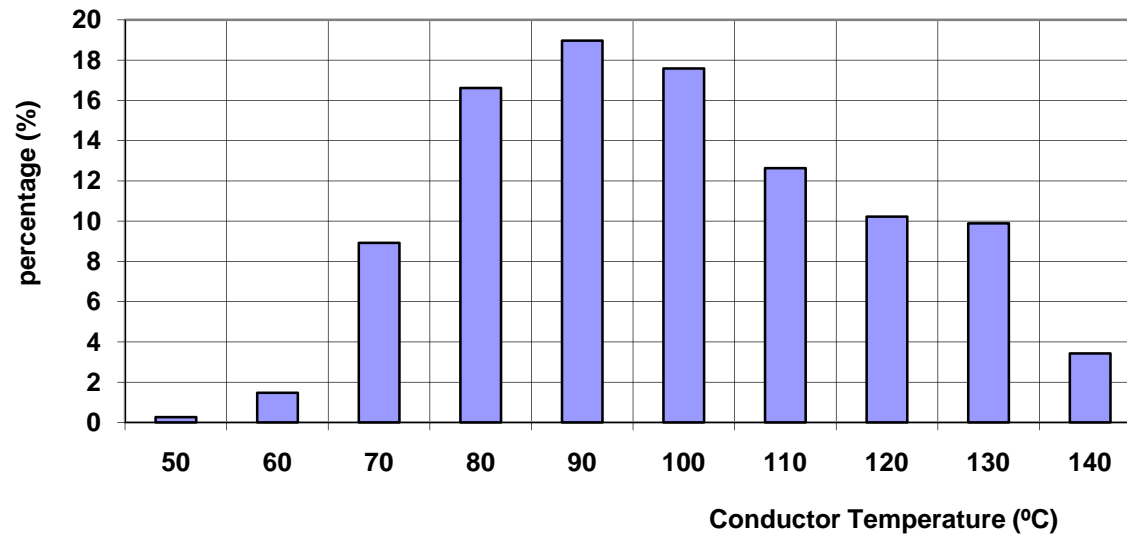
Figure 3 - Hourly average of conductor temperature in the Experimental Line.

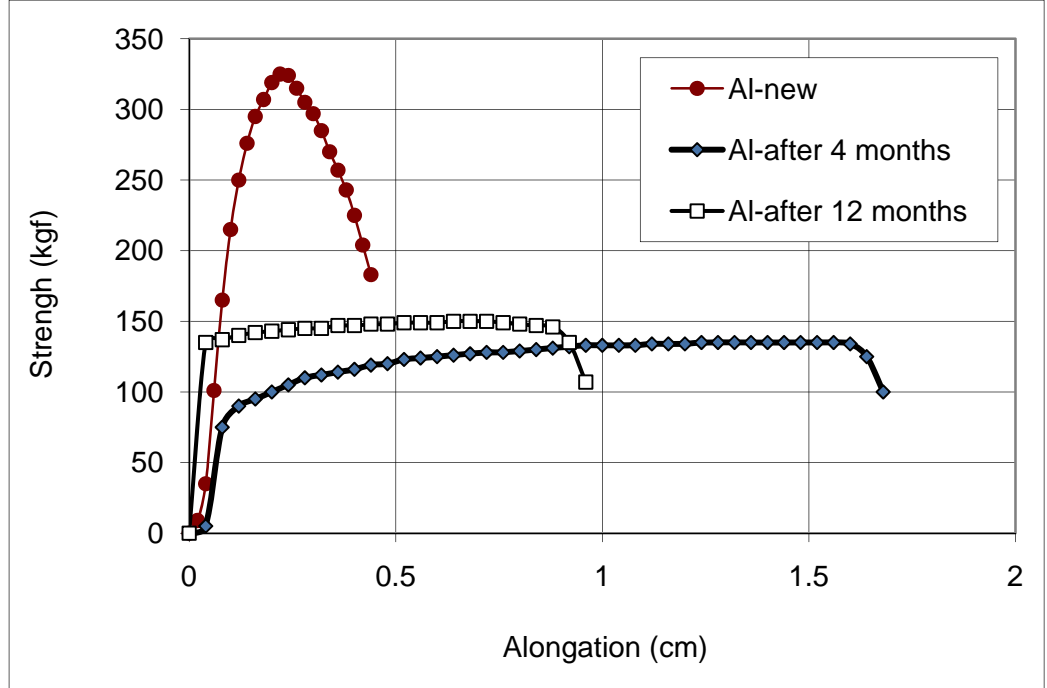
Figure 8 - Tension-deformation diagrams for the alloys wires view.
