XWGB2-02_HighTempLimits – Chair, LenCuster**xWG – Thermal Aging of Conventional Conductor Systems****Task: Comparison between ACSR and TACSR Penguin Conductor****by:****Do Nascimento, C.A.M. and UEDA, S. - Brazil****1. Introduction**

2. CEMIG's Experiment with Task Force Aging of ACSR and TACSR Conductors

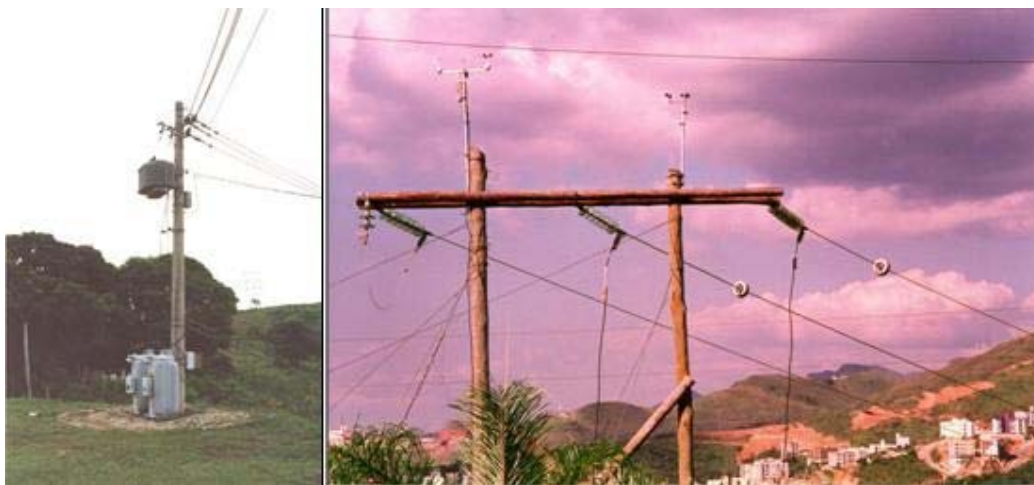
Figure 2 – Power Transformer System (300 kVA), two Reguladores de Tensão, Power Donut Sensor of Monitoring Temperature System and Weather Station in Experimental Line

The current in Experimental Line was regulated through the voltage regulator that maintains a level of line voltage almost constant, so the maximum line current ($I_{max} = 680 \text{ A}$) is controlled. Figure 2 shows the transformer (300 kVA) and two voltage regulators used.

The surface temperature and current sensors were installed in Experimental Line by using the Power Donut Technology, where each sensor works in contact with the conductor and transmit this information direct by radio to a ground station and store them in data acquisition system.

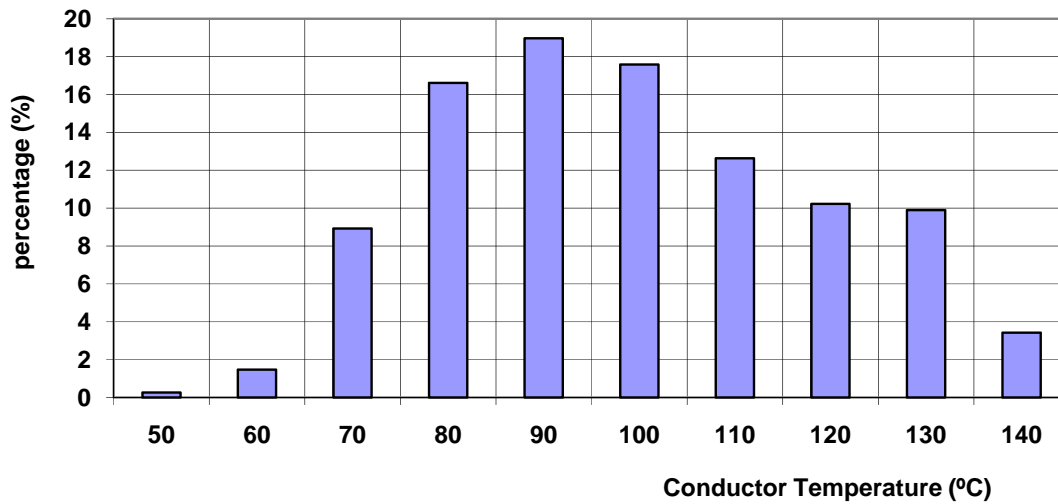
Figure 3 - Hourly average of conductor temperature in the Experimental Line.

All conductors of Experimental Line were kept at high temperature for one year to compare the performance of the traditional ACSR 1350 alloy conductor (new one). Figures 3 to 5 show the profile of the variations of hourly average of conductor temperature and current and on site hourly average of wind speed, respectively.

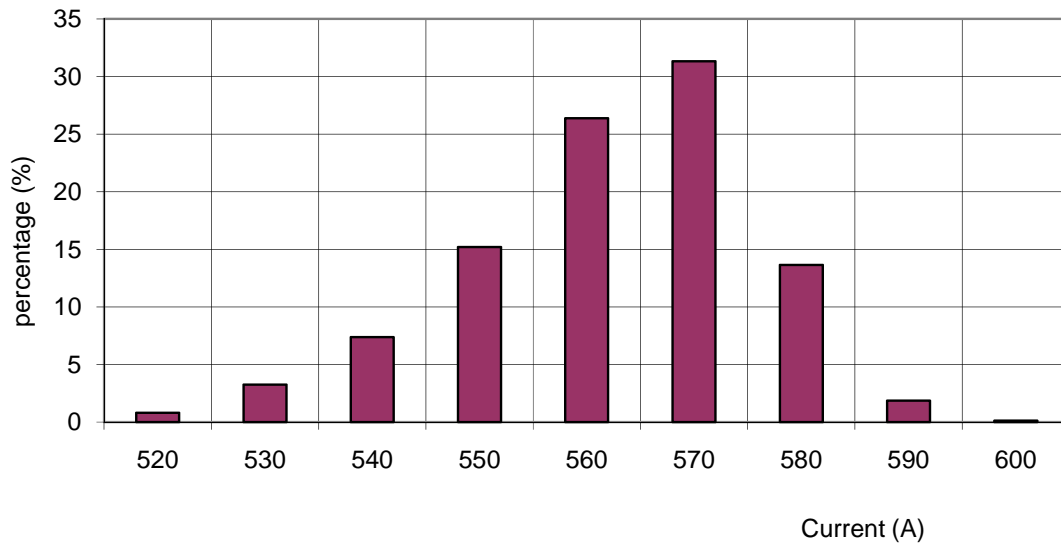
Figure 4 - Hourly average of current in the Experimental Line.

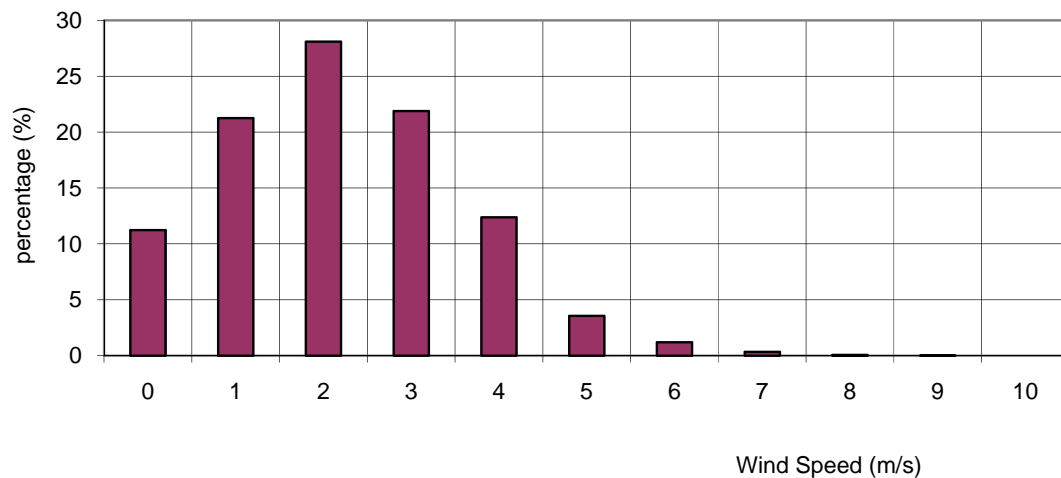
Figure 5 - Hourly average of wind speed in the Experimental Line.

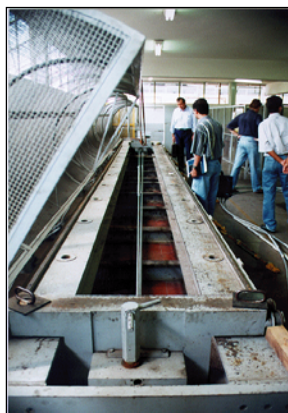
Figure 6 - Conductor break tests in horizontal traction machine of 40 tons view.

from the conductors for all stages of experience. Conductor break tests were made in horizontal traction machine of 40 tons (where 8 meter of conductor of sample was pulled until to break as shown in Figure 6).

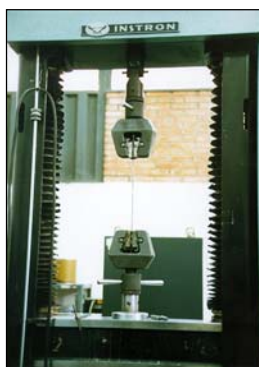
Figure 7 - Aluminum and steel wires vertical traction machine of 10 tons view.

The aluminum and steel wires were also tested separated on a vertical traction machine of 10 tons as shown in Figure 7.

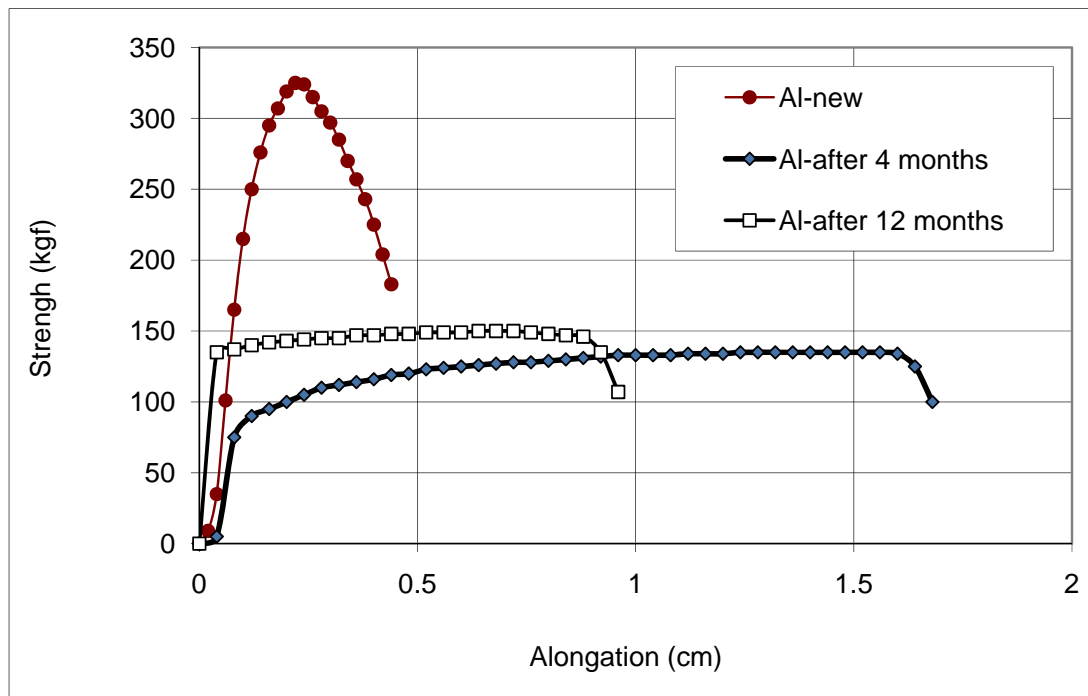
Figure 8 - Tension-deformation diagrams for the alloys Al 1350 wires view.

The Figures 8 and 9 show the tension-deformation diagrams for the alloys Al 1350 and TAL wires. It was observed that after 4 months in operation the conductor is subjected to heat treatment, due to high temperature in the Experimental Line.

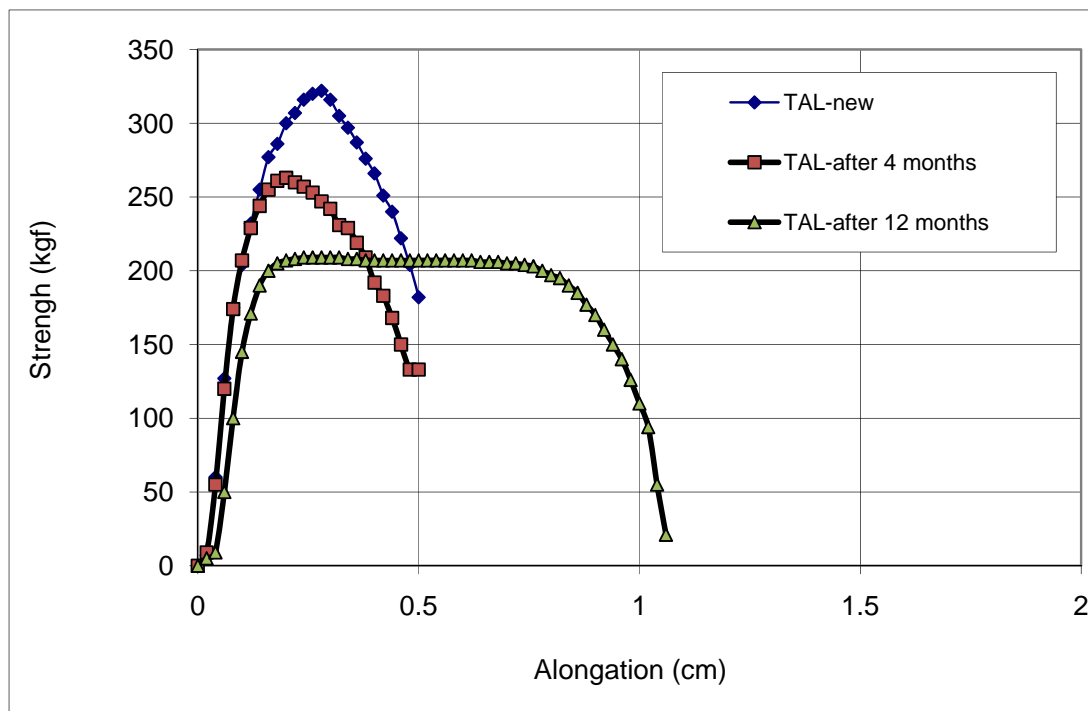
Figure 9 - Tension-deformation diagrams for the alloys TAL wires view.

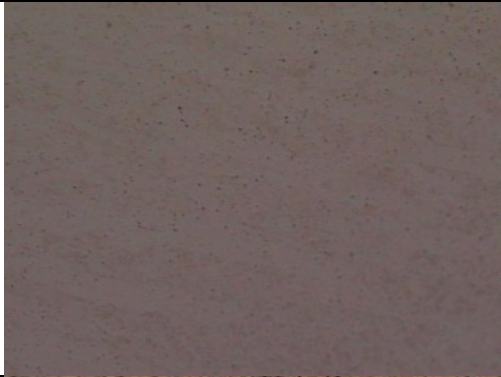
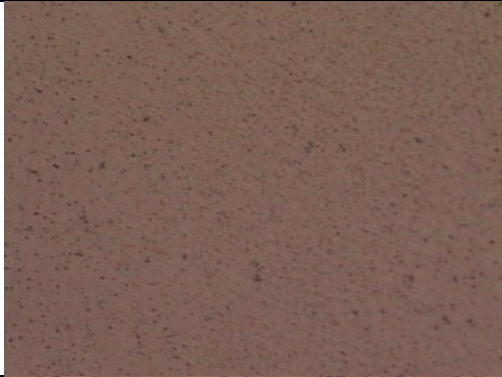
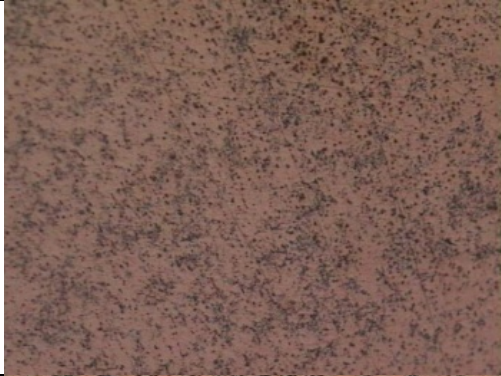
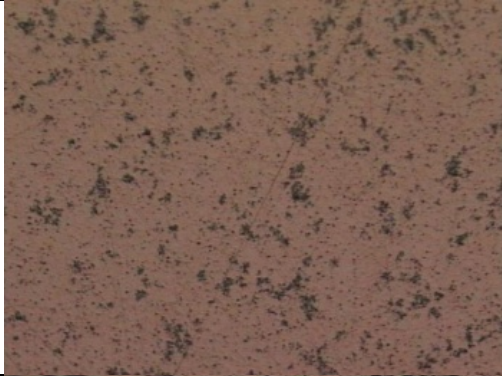
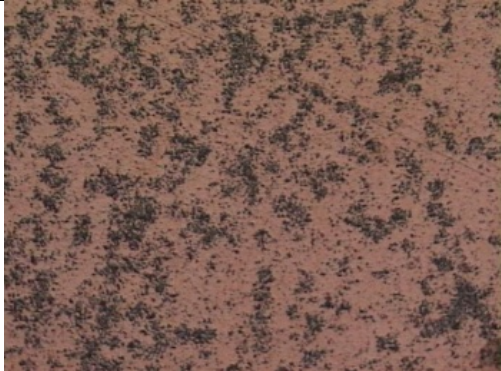
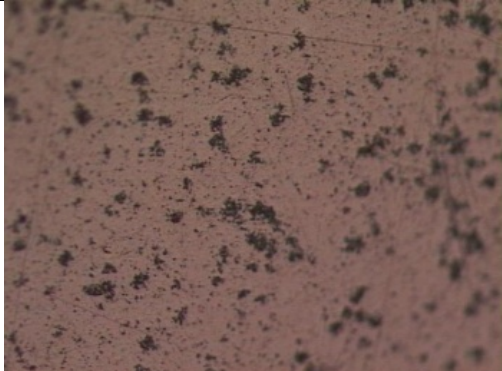
TABLE 4 – Samples of Metallography of Wires

In metallography of TAL alloy was observed the highest percentage of inclusion of zirconium (Zr), shown by dark spots at left side column at Table 4. This chemical works to the grain boundaries of the alloy helping to increase the temperature of annealing of aluminum alloy. Table 4 shows even the behavior metallographic and tensile strength of conventional aluminum alloys Al 1350 and TAL. Note that, with the loss of mechanical strength of the material, there are inclusions, observed in the metallographic images of conventional alloy by formation of crystals that indicate aging of the material. In TAL alloy, this phenomenon is reduced according to the metallurgical properties of the chemical element zirconium in the formation of this alloy. In metallography of steel core no significant difference could be observed as shown in Table 5.

The metallographic analysis confirmed visually mechanical loss observed in the conductors tested and indicating a direct correlation between the graphs of loss of mechanical strength and its metallographic images.
